# Inspection Report

## General

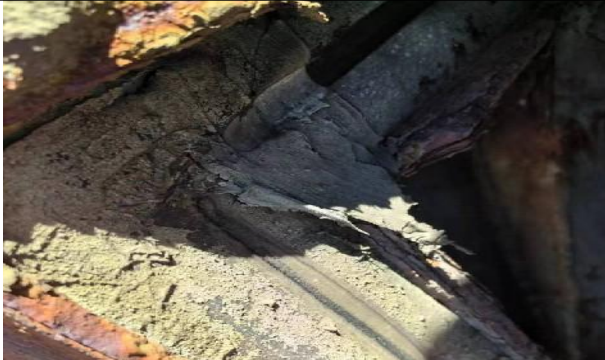
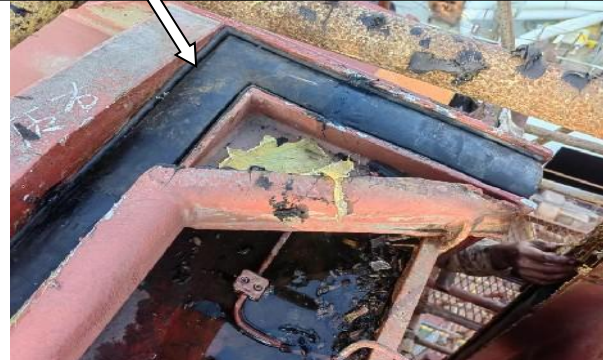
| <p><b>Wrong installation</b> --missing flat corner in hinge Joint</p> | <p>Correct packing installation with one flat corner and one L-standing corner</p> |

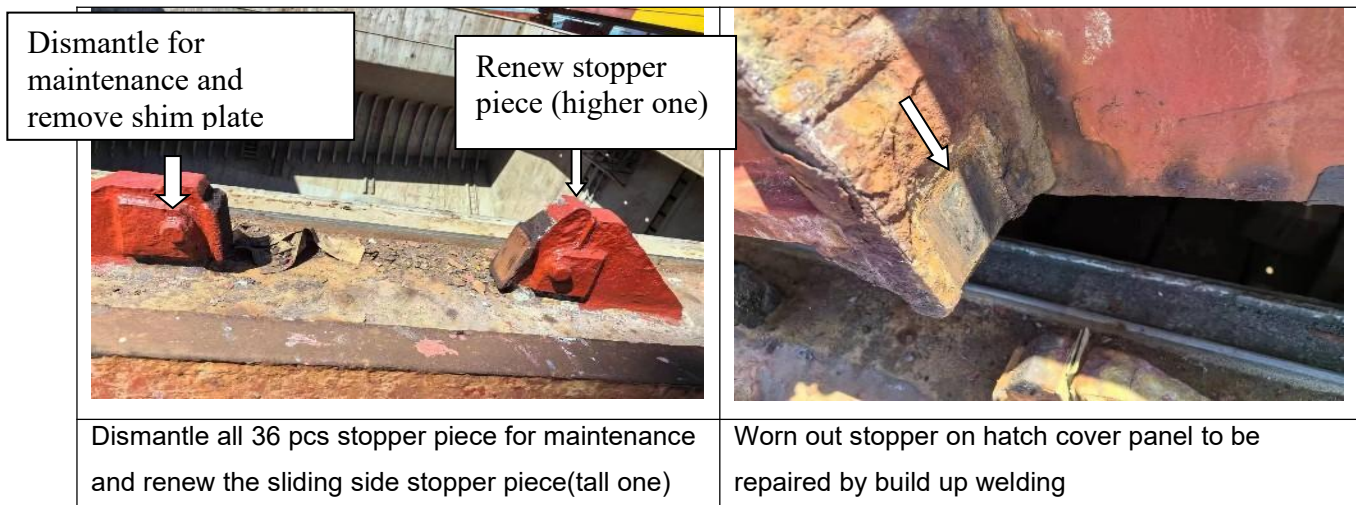
- The sliding surface need to be greased to reduce the worn down and smoothly operation.
- Wheel stopper in **No.1AS** and **No.5FS** were deformed/worn out suggest to be renewed. And the wheel stopper in starboard side were stuck, suggest to be free up. **Pic15**

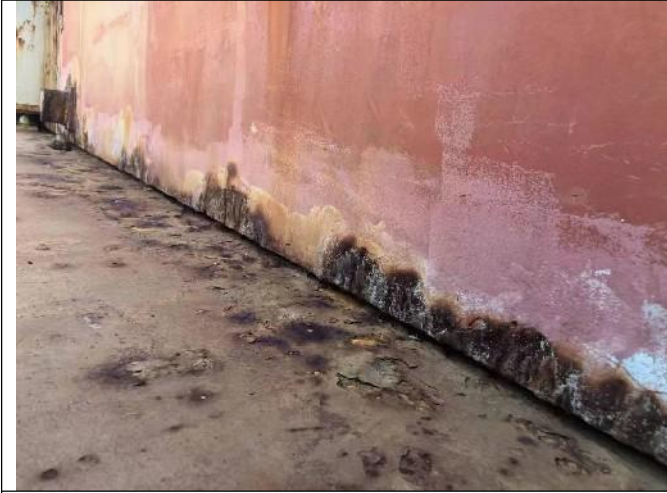
P1.hatch cover skirt plate corroded

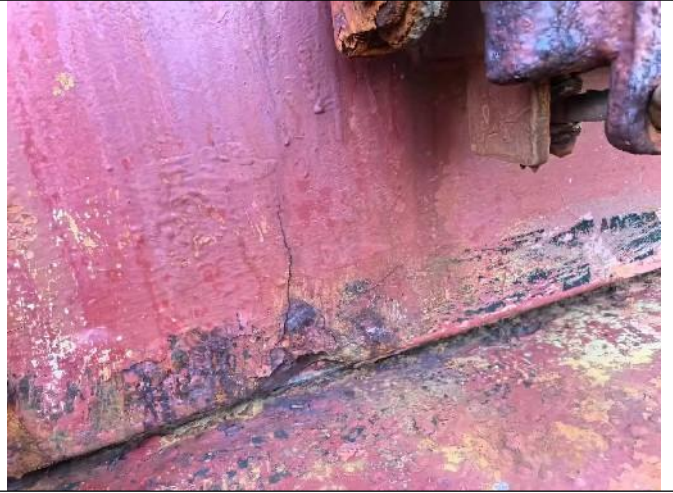
P2. water drain channel in panel joints corroded heavily

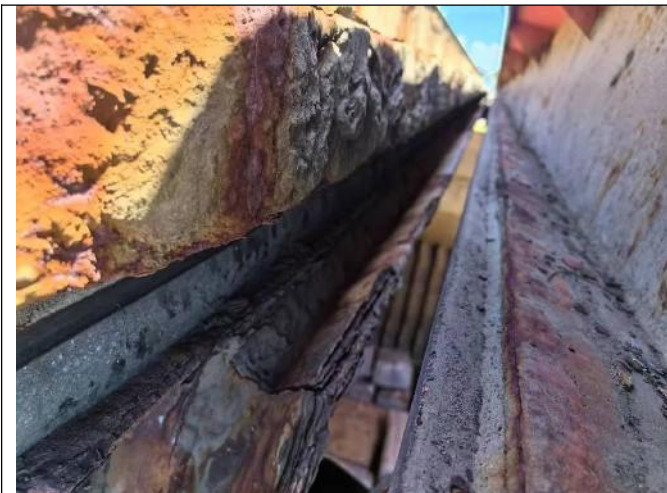
P3.Hatch cover panel joints corroded heavily

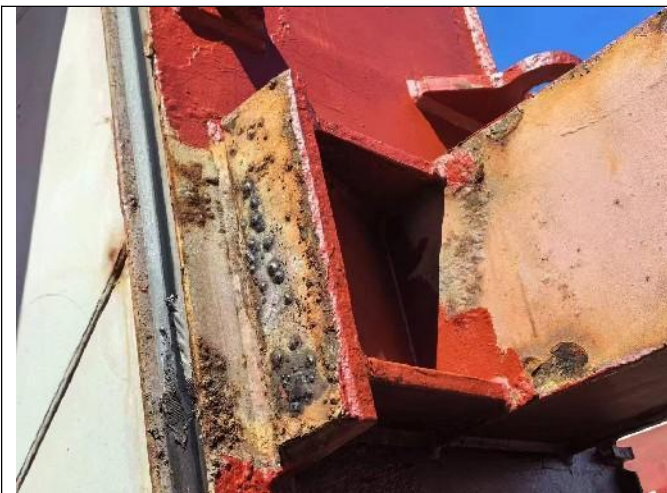
P5. Mating plate corroded

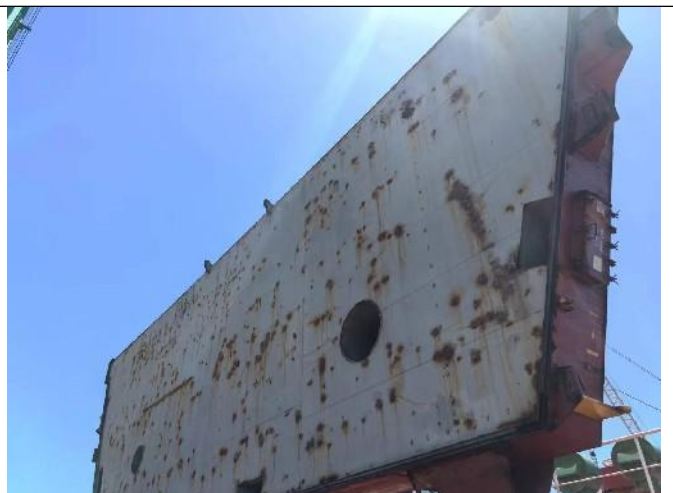
P6.hatch cover underside rusty

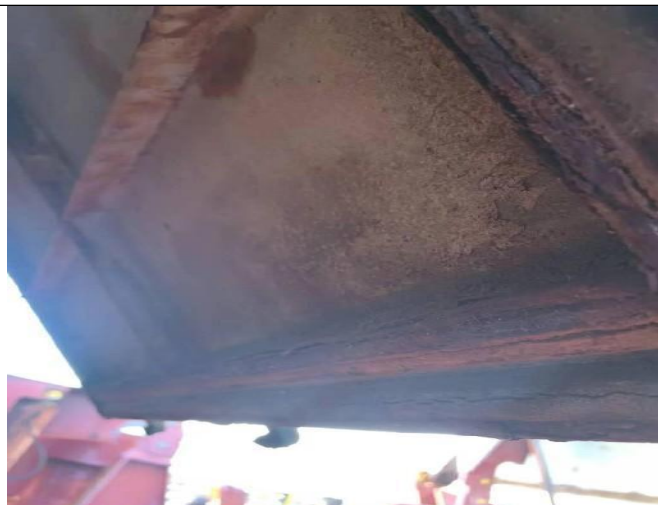
P7. Corroded ventilation doors,

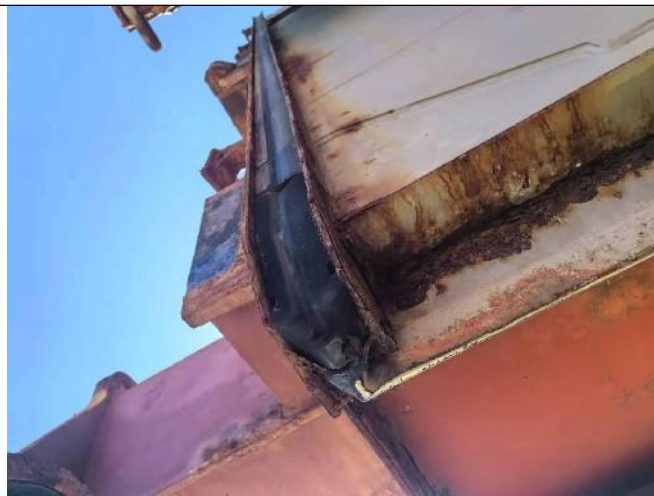
P8. deformed rubber corner

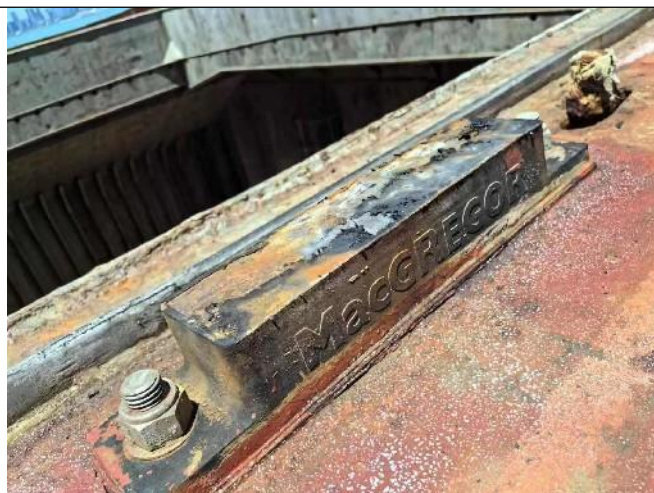
P10. damaged flexipad

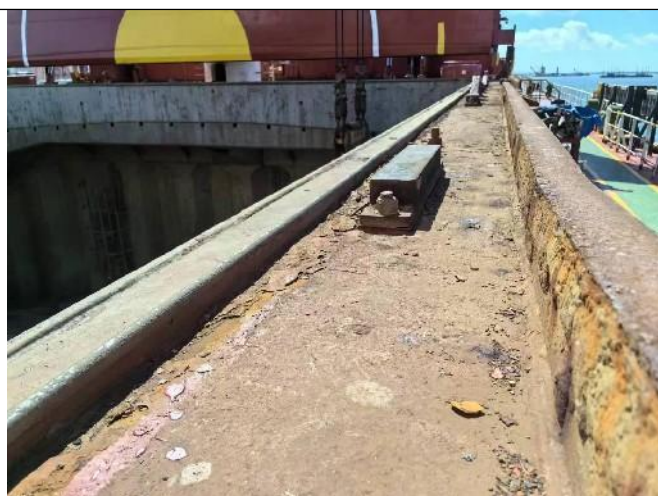
P11 coaming top corroded

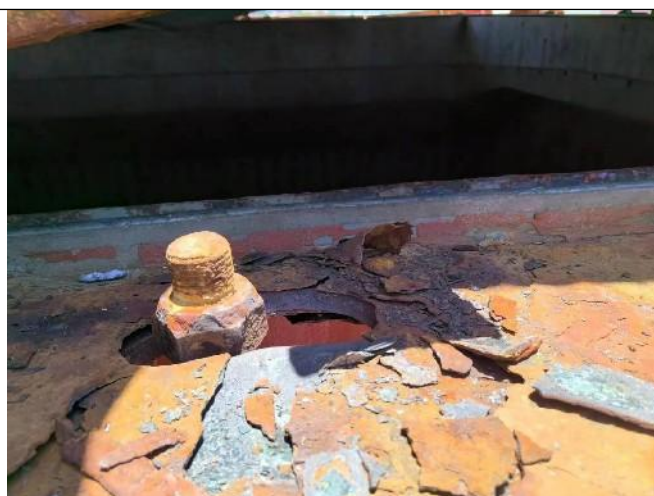
P12. cleat hole plate deformed

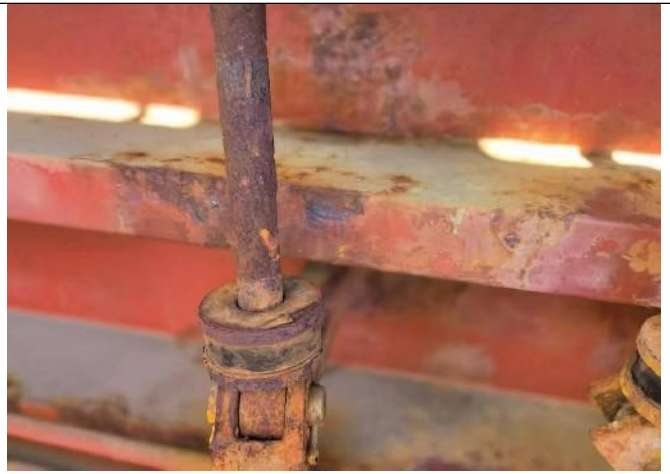
P14. cleat corroded heavily

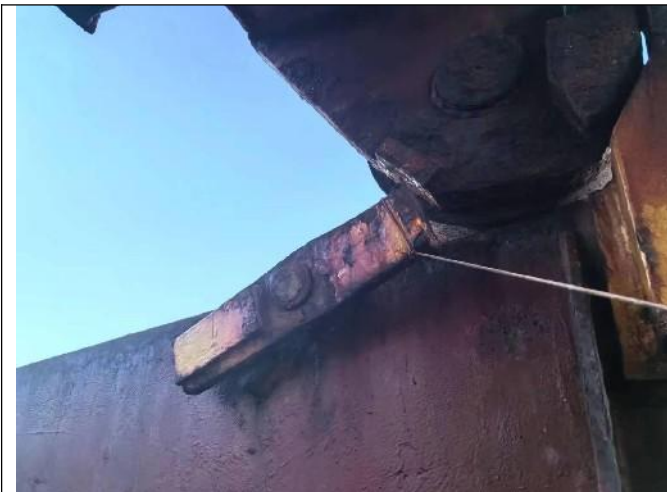
P15 wheel stopper worn out

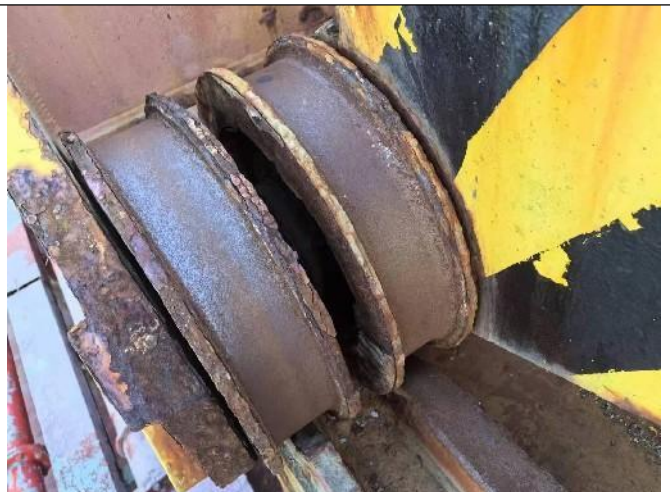
P16. Running wheel corroded heavily

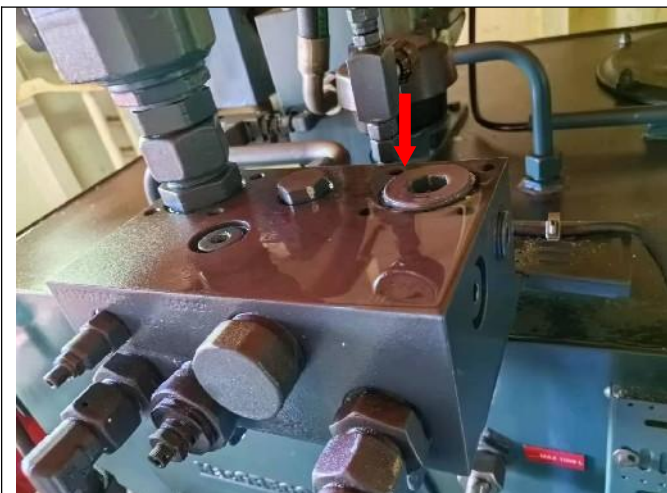
P17 Leaking of plug in Pump station

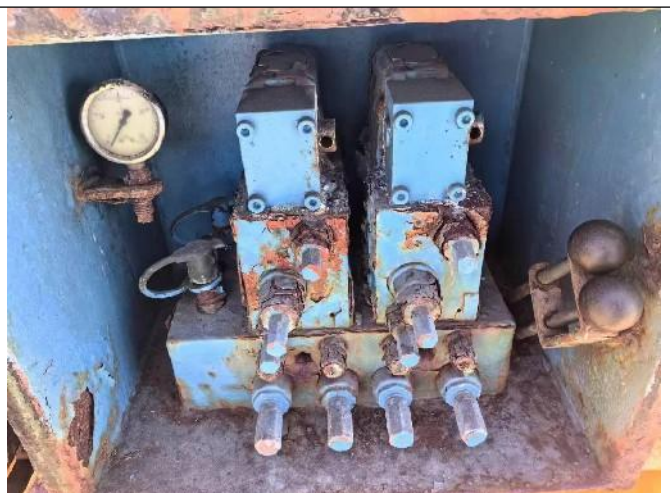
P18. Hatch cover control stand corroded

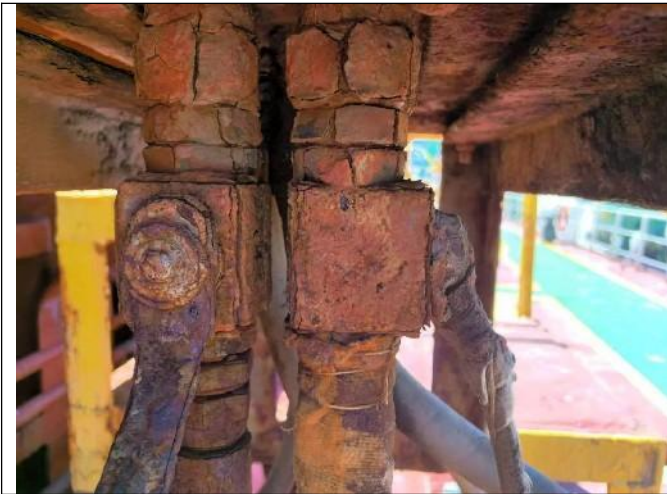
P19 Ball valve under control stand corroded and stuck

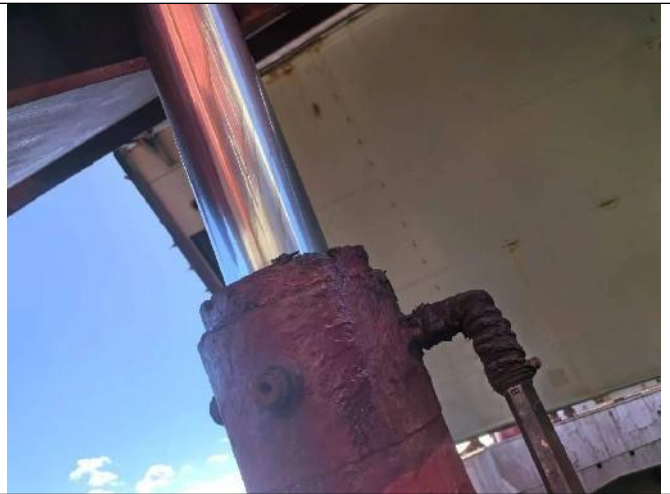
P20. Leaking of hydraulic cylinder

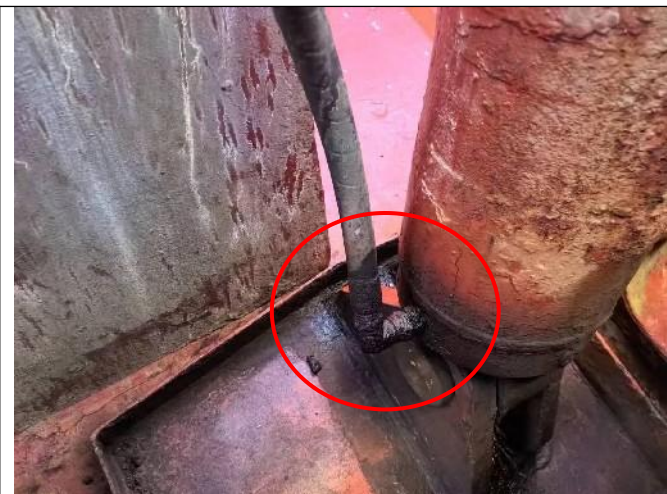
P21 Leaking of bottom hose adaptor of cylinder

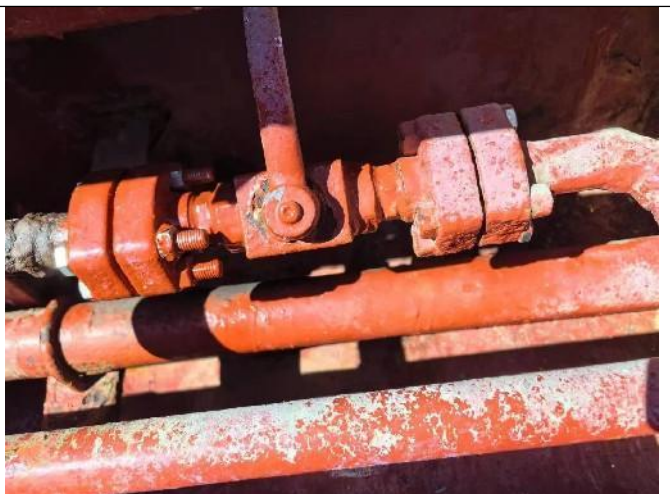
P22. leaking of bypass valve

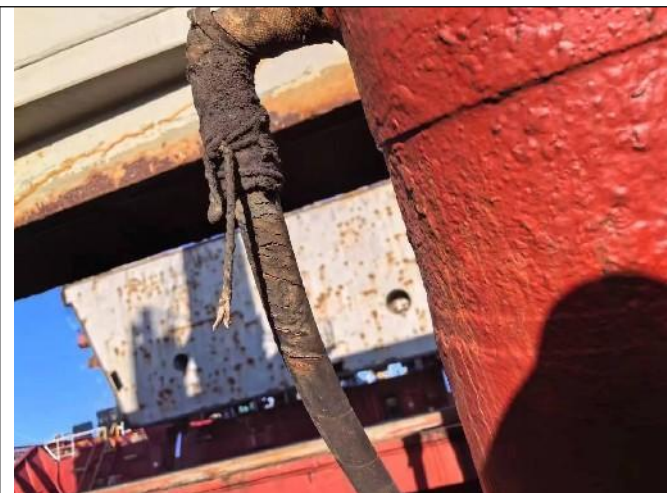
P23 cracked hydraulic hose

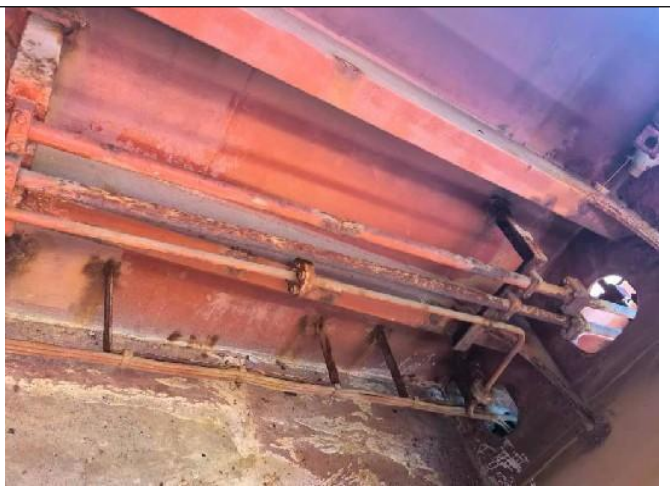
P24. corroded hydraulic pipe

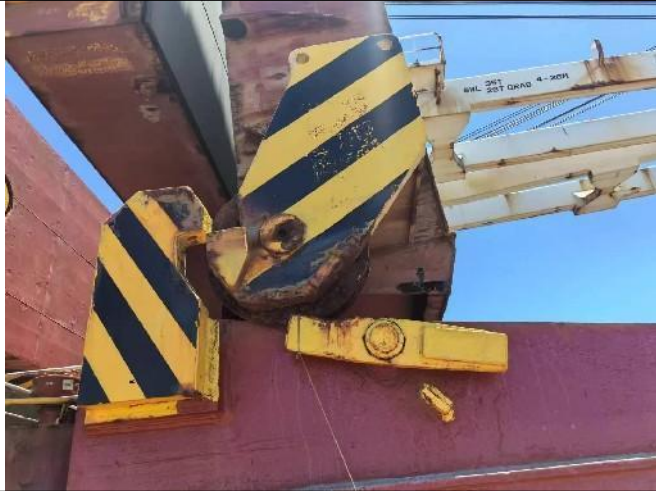
P25 hatch cover panel unable to fully open before adjustment

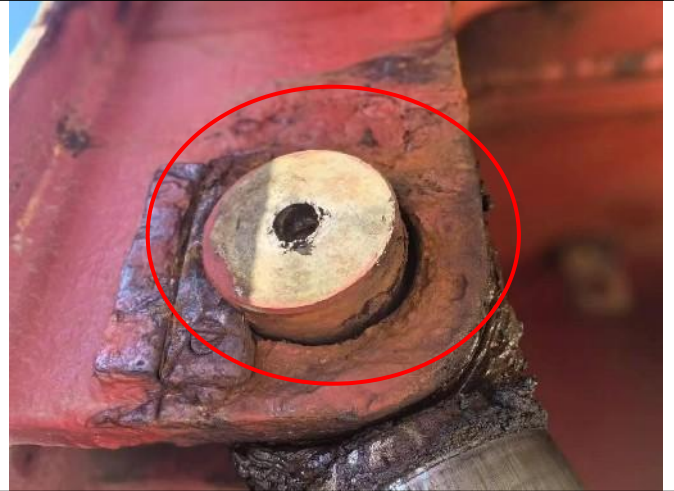
P26. worn out top cylinder eye

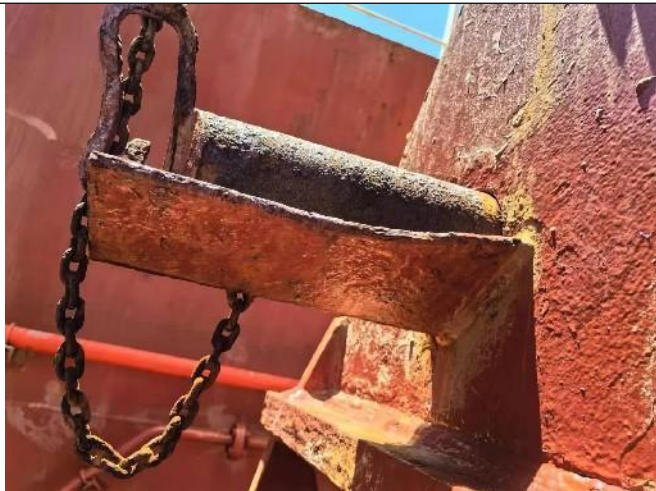
P27 end stopper pin in No.1 Fwd unable to locked And deformed bracket

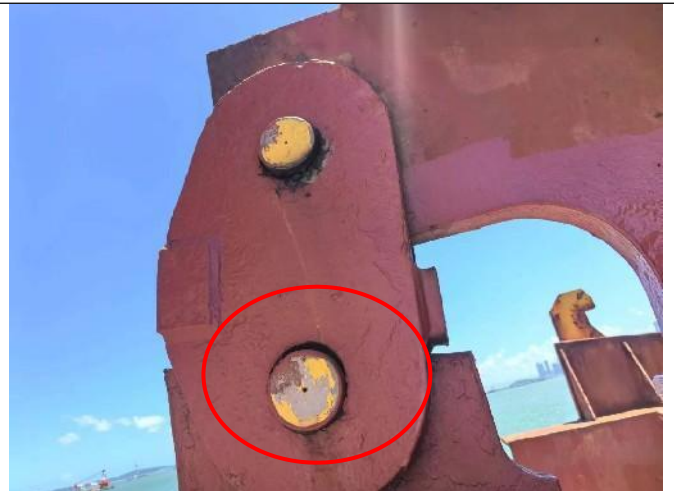
P28. worn out end hinge link

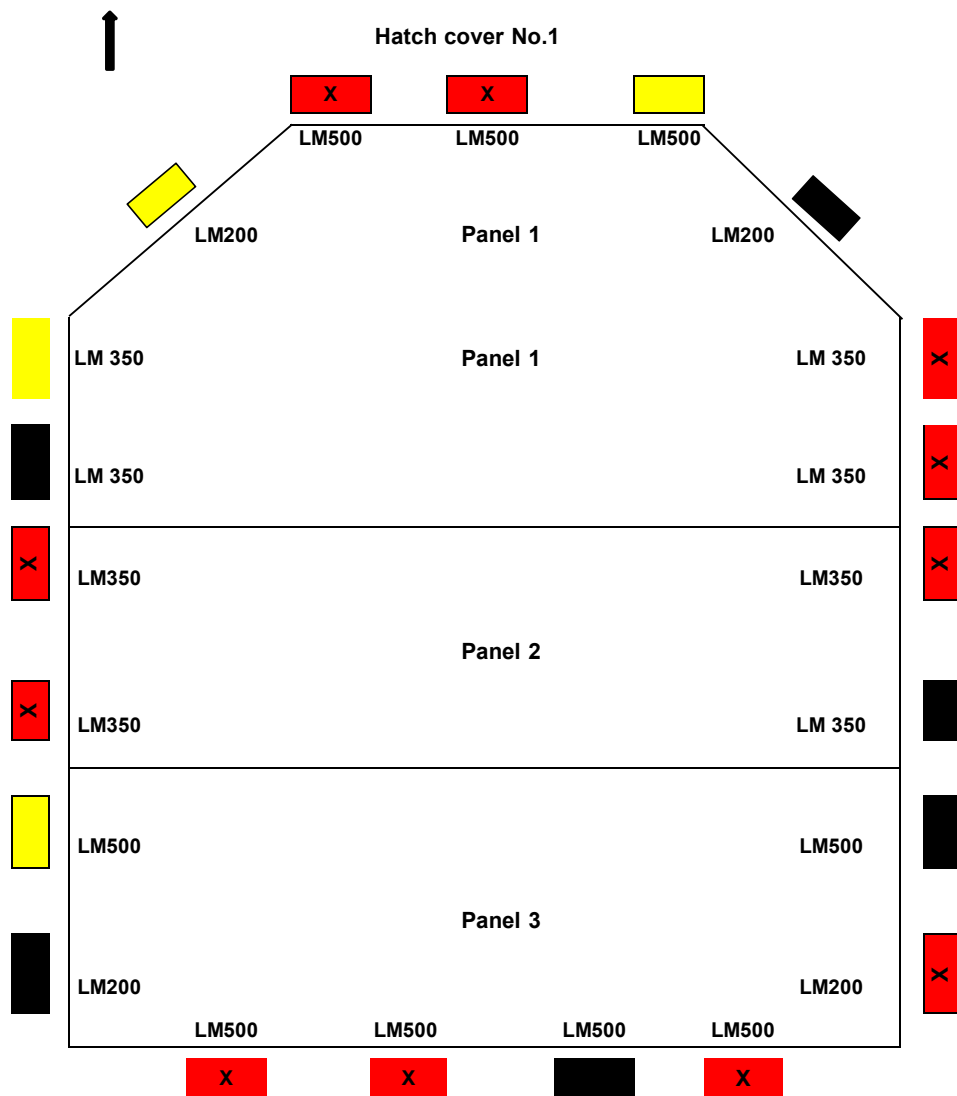
## Flexipad arrangement on coaming

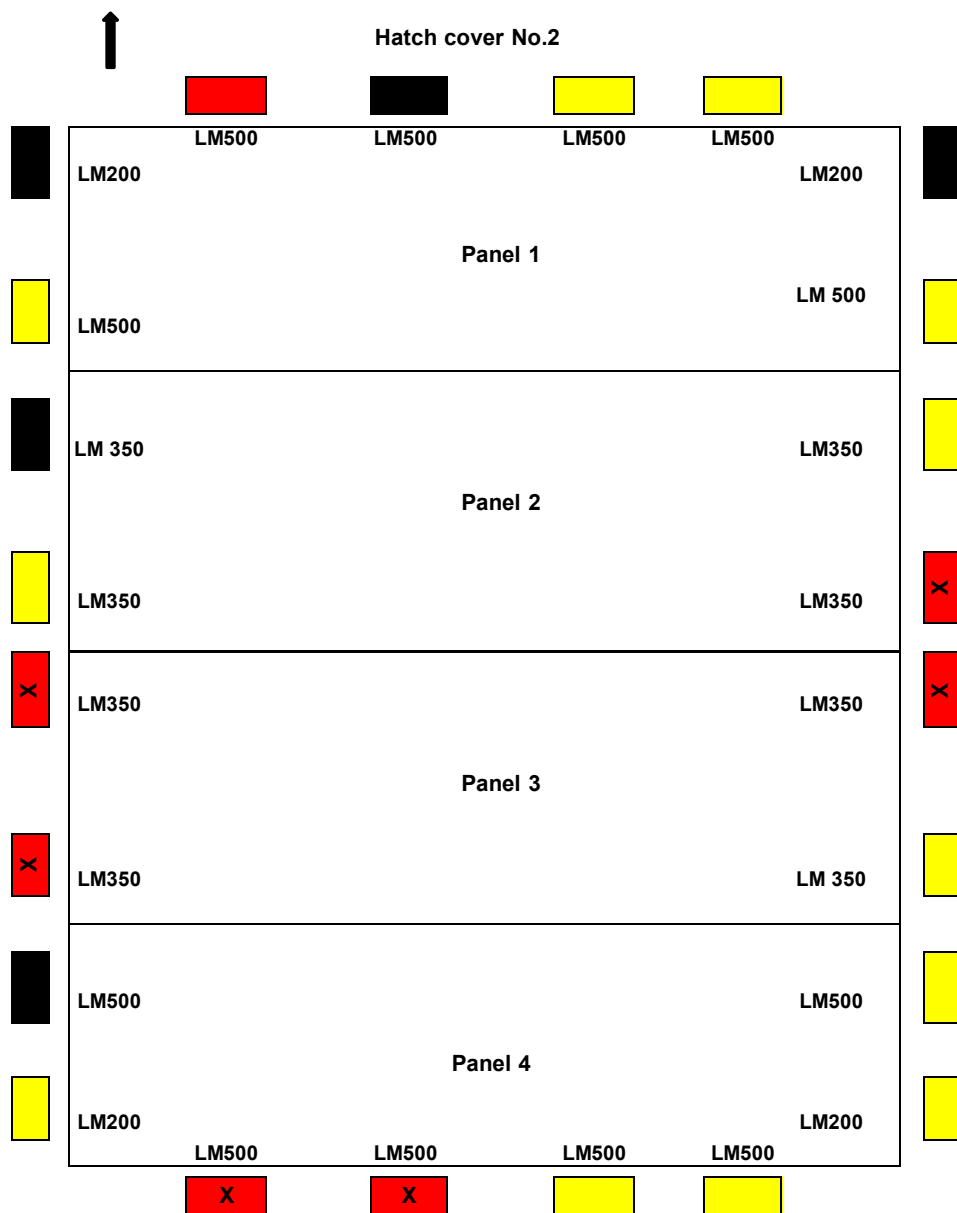
X Flexipads which damaged need to be replaced in this drydock

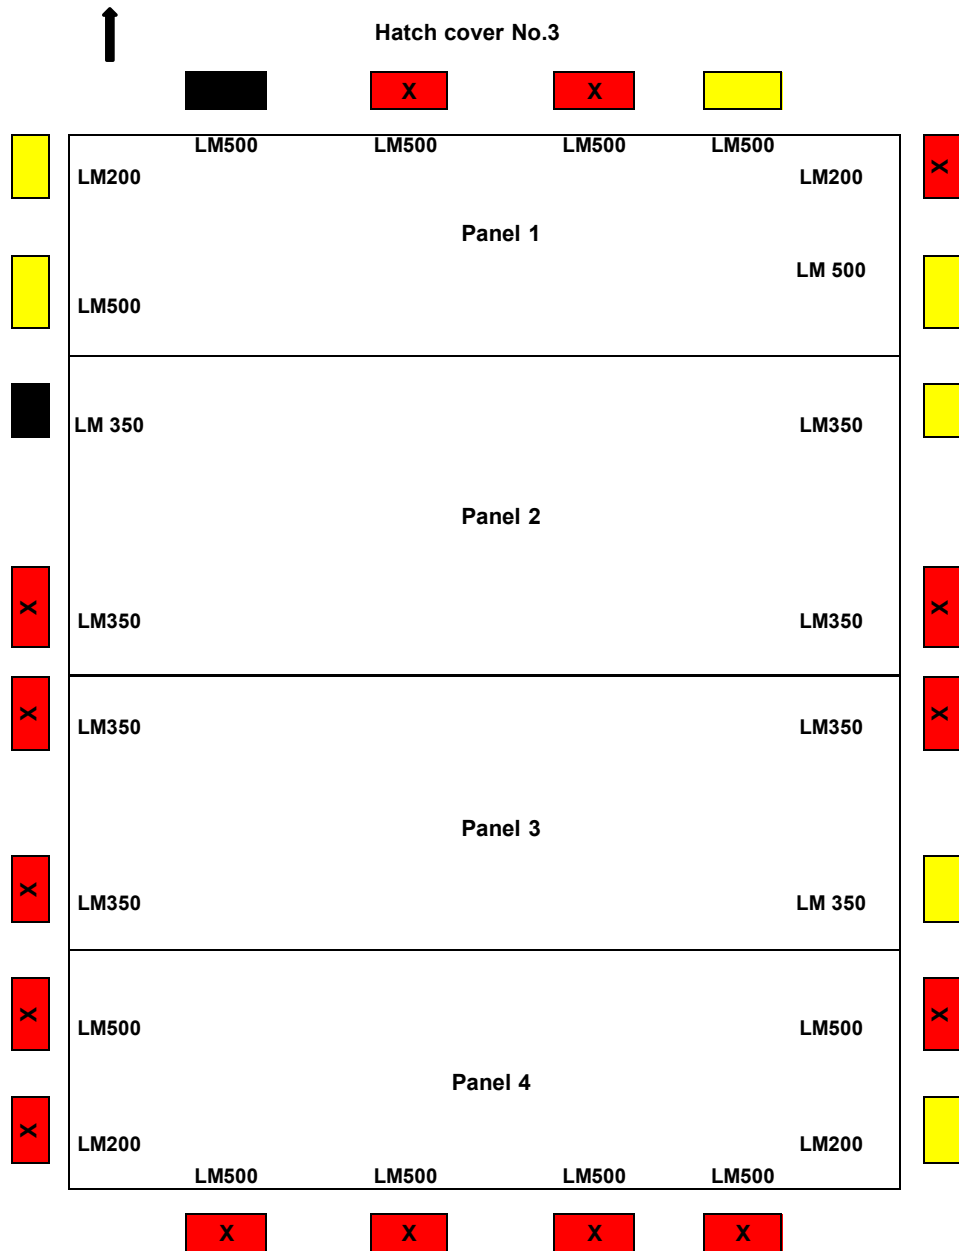
Flexipads which were in normal condition

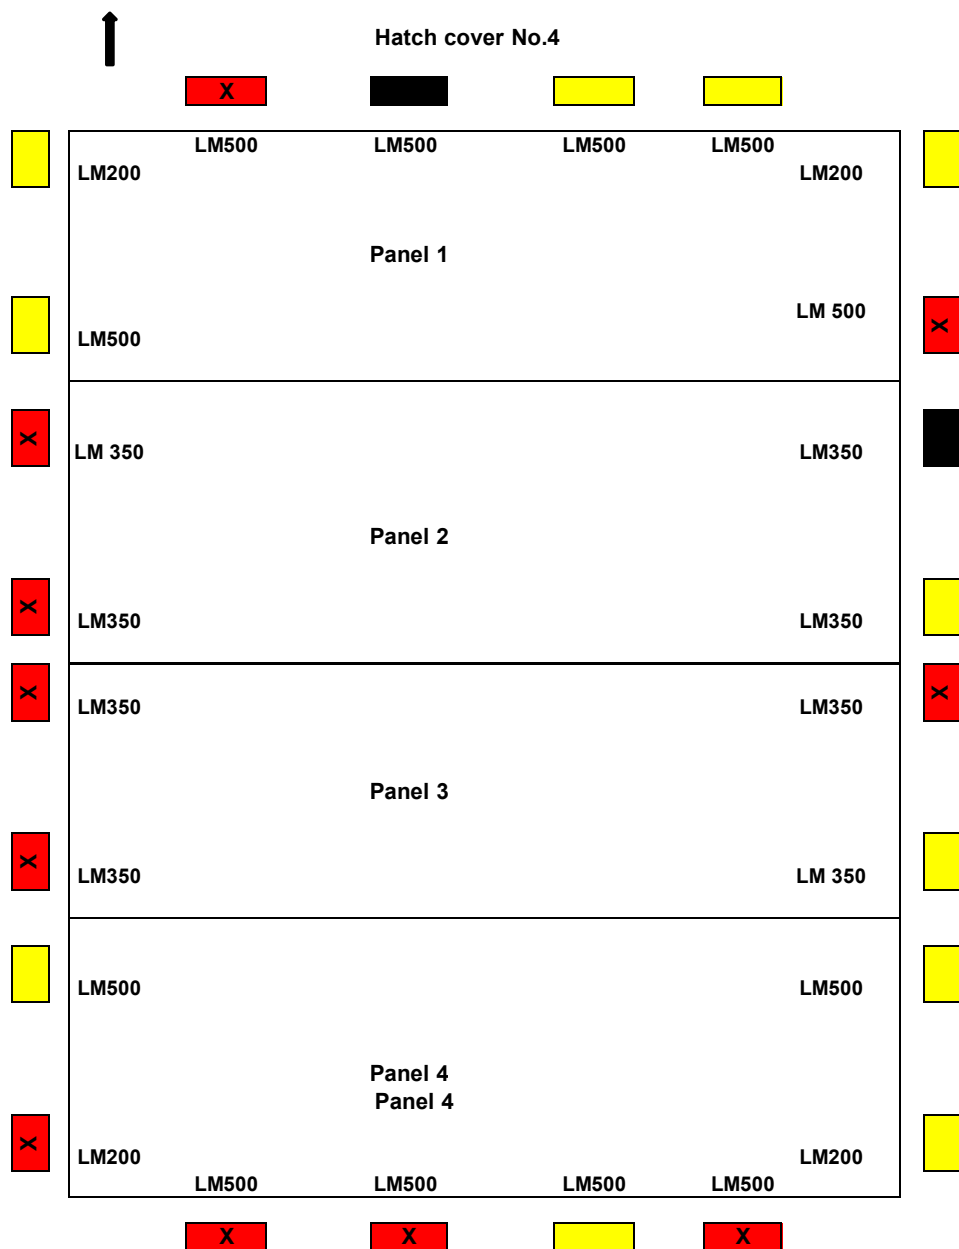
Flexipads which were in normal condition

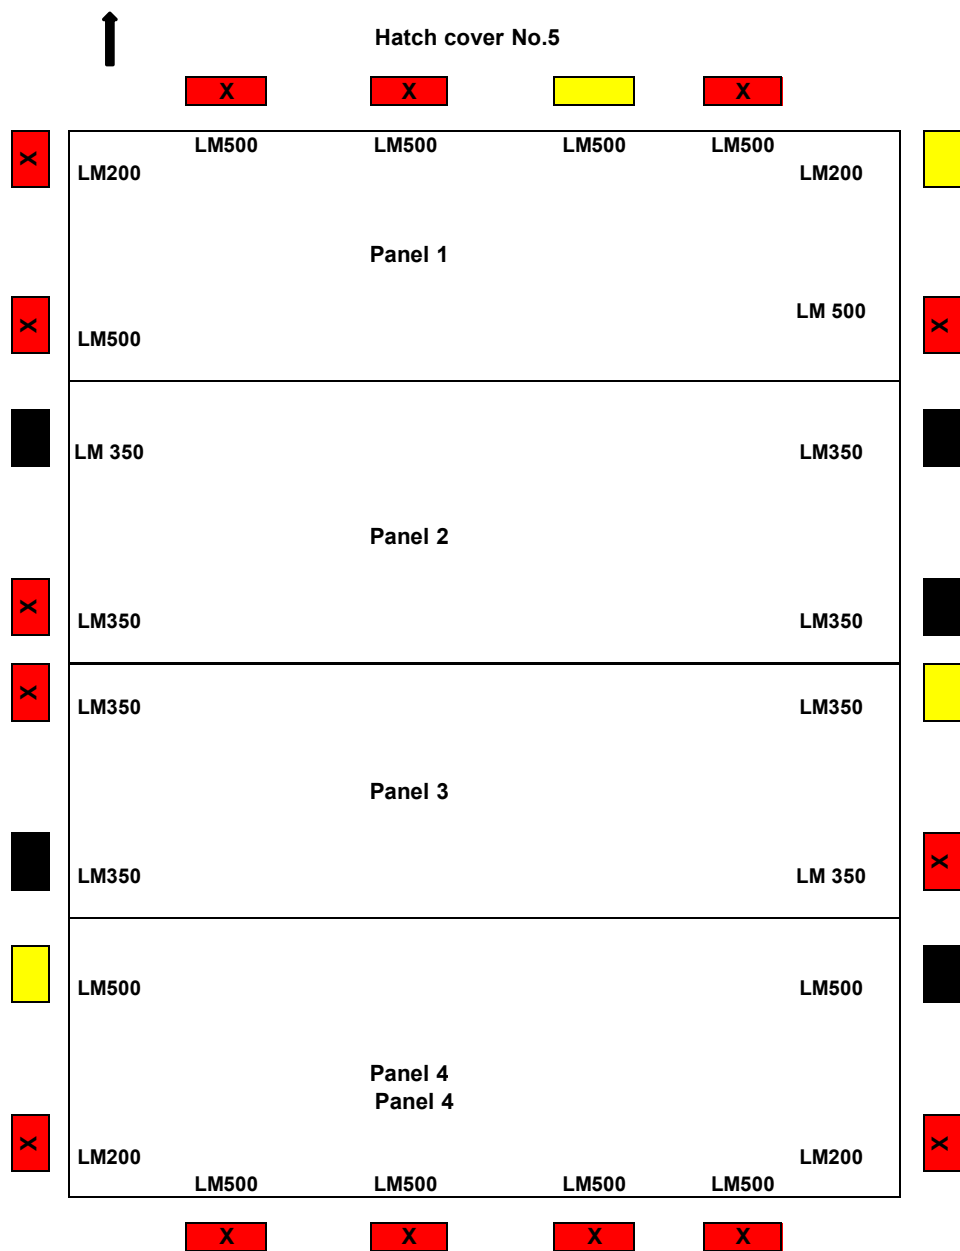
Flexipads which were in normal condition
