# **Service Report**

То:		Customer:	
Vessel name:		IMO No.:	
Engineer:		Job No.:	SE-240730-49203
Date:	03/08/2024	Place:	Hua feng shipyard

Job description General inspection for MHI deck cranes

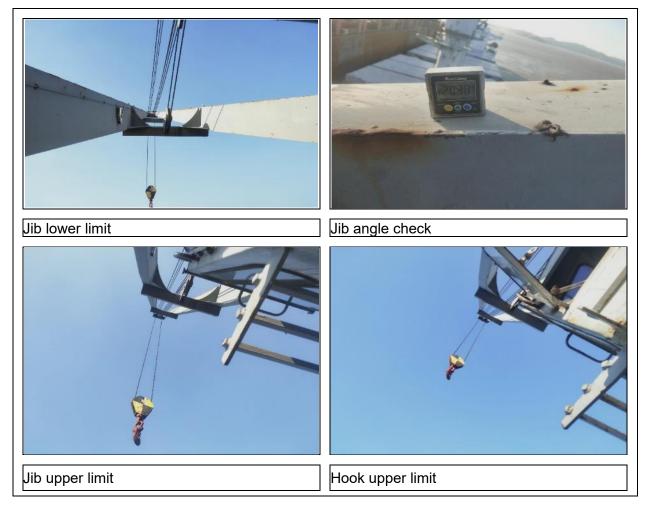
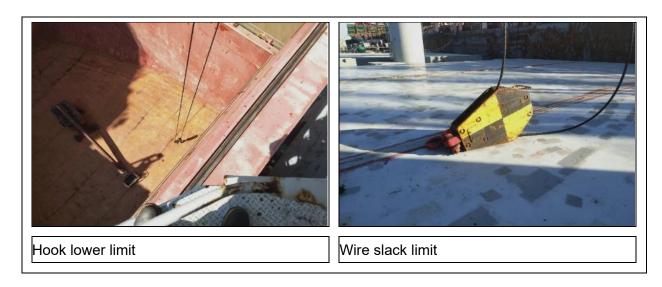
CHECK	KITEMS	Crane 1	Crane 2	Crane 3	Crane 4
HOISTING	UPPER	Normal	Normal	Normal	Adjusted to normal
LIMIT SWITCH	LOWER	Normal	Adjusted to normal	Adjusted to normal	Normal
LUFFING LIMIT	UPPER	Normal	Normal	Normal	Normal
SWITCH	LOWER	Normal	Normal	Normal	Adjusted to normal
DETECTOR FOR	HOISTING	HOISTING Abnormal		Abnormal	Abnormal
SLACK OF WIRE	LUFFING	Abnormal	Abnormal	Abnormal	Abnormal

Remark: All crane HO&LU wire slack limit not work. Because the limit switch out of position.

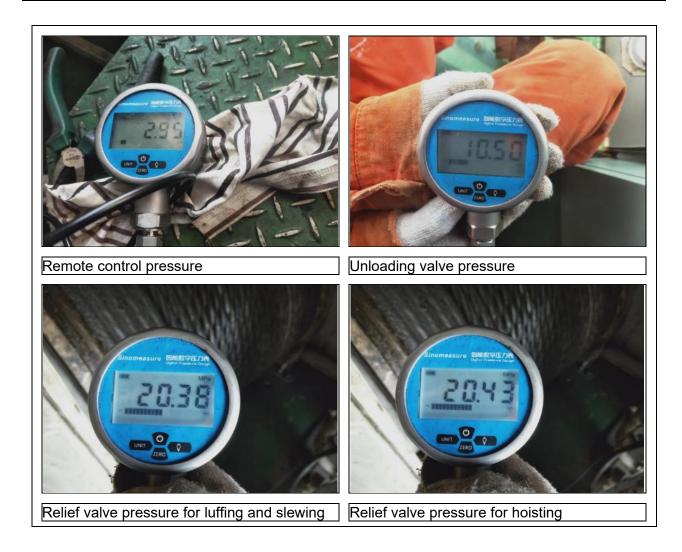
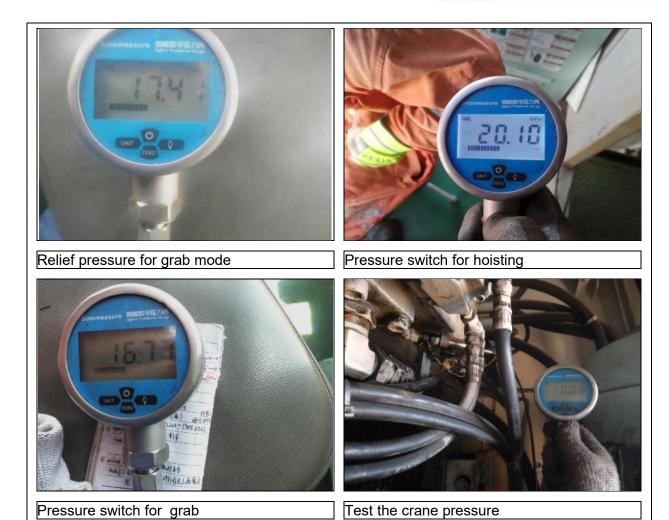
CHECK	CONTENTS	Crane 1	Crane 2	Crane 3	Crane4					
	STANDARD SETTING	STANDARD SETTING 20.6 -Mpa								
RELIEF VALVE FOR HOISTING	BEFORE ADJUSTMENT	20.3	20.5	20.3	19.5					
FORTIOISTING	AFTER ADJUSTMENT				20.4					
RELIEF VALVE	STANDARD SETTING		17.5	-Мра						
FOR	BEFORE ADJUSTMENT	17.3	17.5	17.4	17.2					
HOISTING- GRAB	AFTER ADJUSTMENT	_	_	_	_					
UNLOADING VALVE	BEFORE ADJUSTMENT AFTER ADJUSTMENT	10.6 —	10.8 10.5 —	-Mpa 10.8 —	10.5					
RELIEF VALVE	STANDARD SETTING		20.6	-Мра						
FOR LUFFING AND	BEFORE ADJUSTMENT	20.4	20.3	20.5	20.3					
SLEWING	AFTER ADJUSTMENT	_		_	_					
PRESSURE	STANDARD SETTING		20.0	)- <b>M</b> pa						
SWITCH FOR HOOK	BEFORE ADJUSTMENT	19.8	19.5	19.7	20.1					
110011	AFTER ADJUSTMENT		_	_	_

PRESSURE	STANDARD SETTING		16.0	-Мра	
SWITCH FOR GRAB	BEFORE ADJUSTMENT	16.7	16.4	16.5	15.8
	AFTER ADJUSTMENT	_		_	_
	STANDARD SETTING		2.94	-Мра	
REMOTE CONTROL VALVE	BEFORE ADJUSTMENT	2.92	2.91	2.93	2.82
	AFTER ADJUSTMENT	_	_		2.95
