# Service Report

Attended on board as per customer's requirement to carry out inspection of grab when vessel docking repair in jiushun Shipyard

Equipment: 14 cbm REDIO REMOTE CONTROL GRAB

Maker: GUVEN Kepce Makine İc ve Dis Tic.Ltd

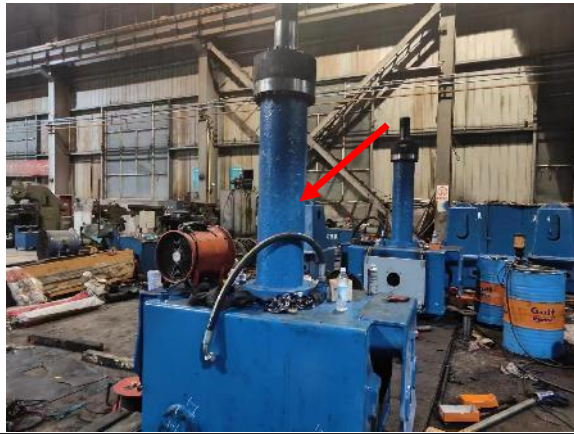
P1.the grab had been overhauled

- All 4 grabs had been overhauled,all the pins of scoop and arms had been dismantled and clean the grease passage,all the bush of scoop pins (16pcs) and arm pins (64pcs) had been replaced.Pic.01-02

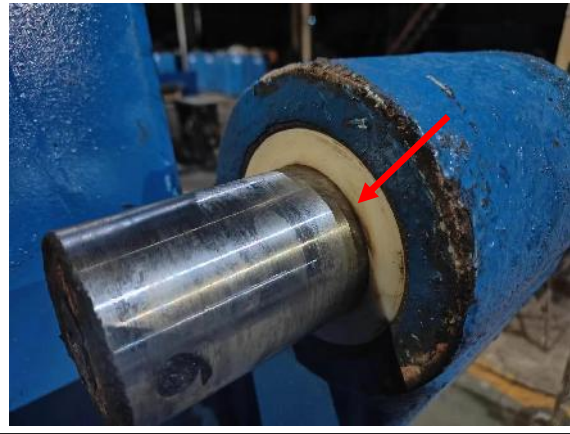
P2. the bush had been replaced

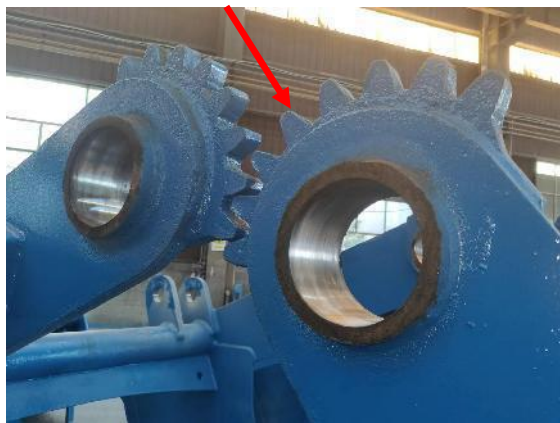
P3. scoop pins gear apply grease

- All four grabs scoop pin gears had been applied grease by manually to avoid the gears teeth worn-out.Pic.03
- The Master link and lifting plate had been de-rusted and paint.Pic.04
- All the grab shell plate and top frame had been dismantled and performed sandblasting and paint.Pic.05
- 1section deformed plate on the **NO.2 grab** top frame had been straighten by heating.Pic.06
- 2pcs deformed steps of **NO.1&2** grab had been replaced.Pic.07
- The bottom sealing strip plate had been replaced and worn out Corner area had been repaired by building welding.the grab had been carried testing with sand,which was working in normal.Pic.08-09
- **1pcs** rubber pads of **NO.3 grab** had been fitted back.Pic.10
- All the wire of grab had been replaced during this docking repair.Pic.11

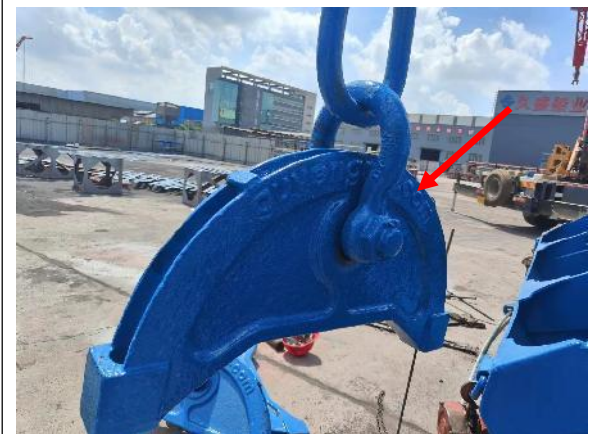
P4.master link plate had been sandblasting and paint

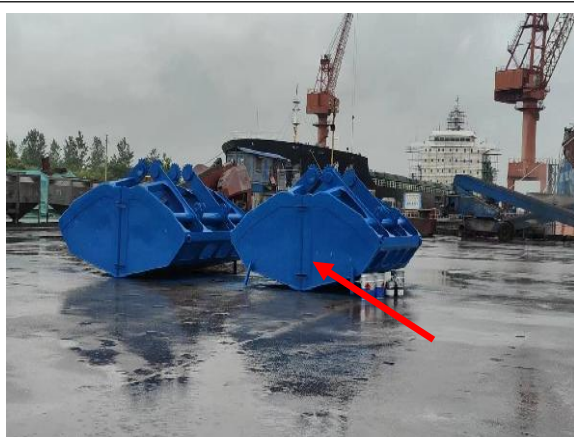
P5. grab shell plate had been sandblasting and paint

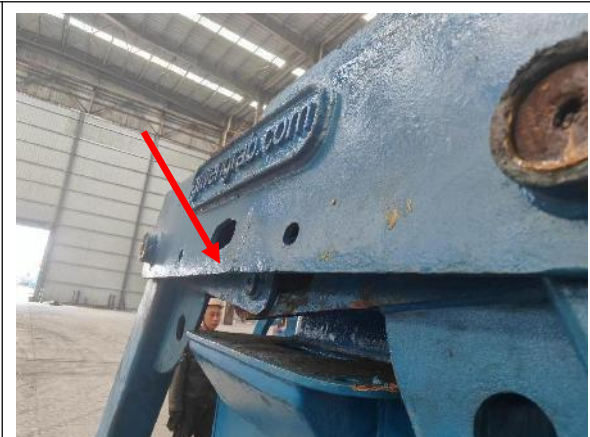
P6.deformed frame had been straighten

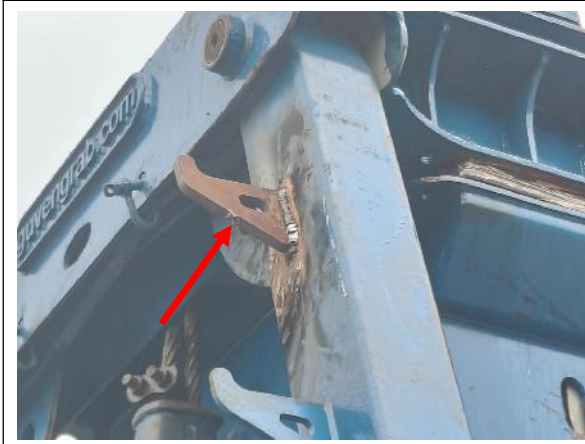
P7.step had been renewed

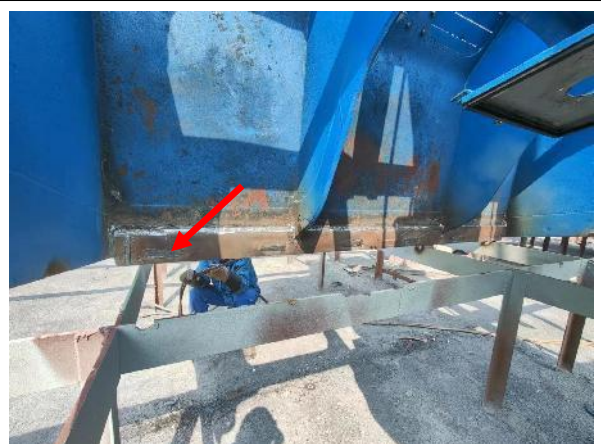
P8.bottom lip had been renewed

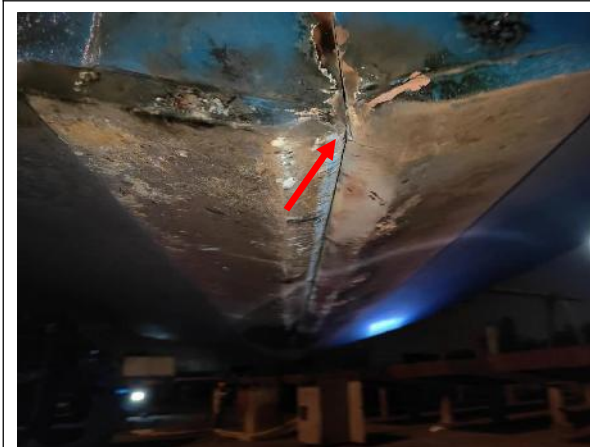
P9. lip corners area had been building welding

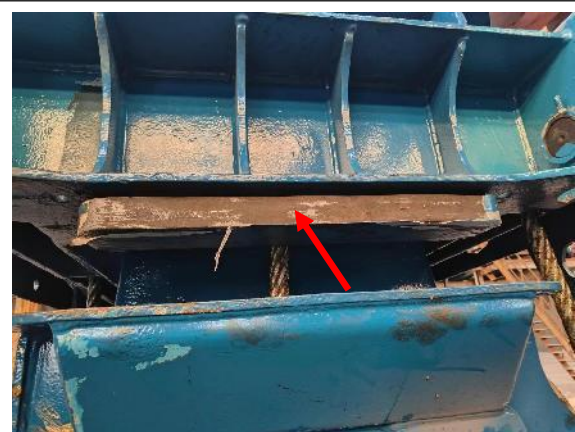
P10.rubber pad had been installed

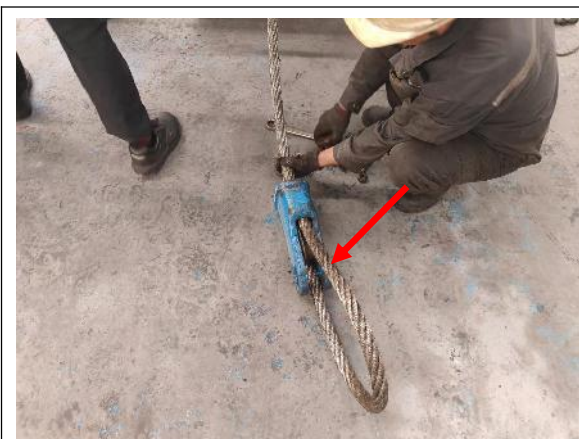
P11. wire renewed

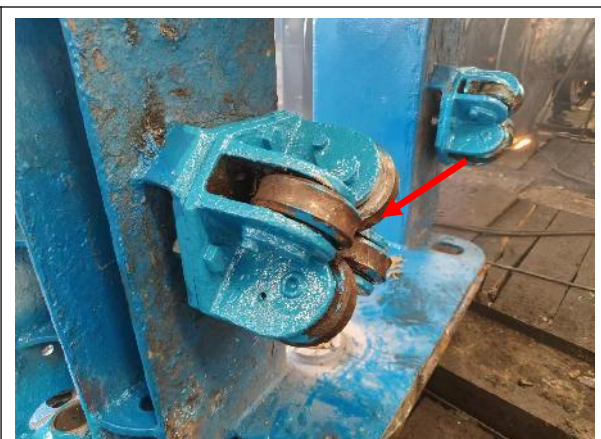
P12. wire guider group had been performed maintenance

- All the wire guider group had been dismantled for maintenance,suggest to apply grease regularly.Pic.12
- All the sheaves had been dismantled for maintenance.Pic.13
- The system room door had been replaced,all the safety pins and butterfly bolts had been replaced.Pic.14
- All the kick plate had been dismantled for sandblasting and painting.
- The system room was rusty heavily ,to be descaled and paint.

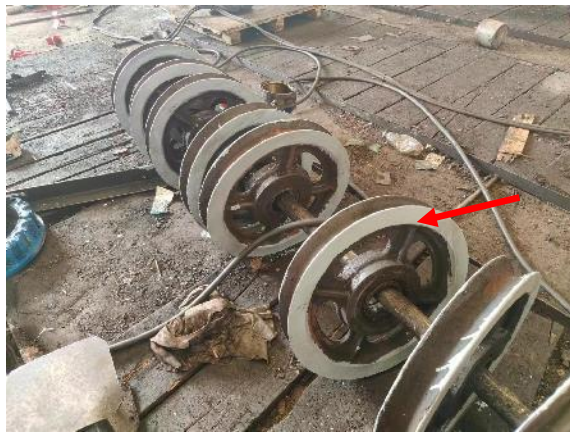
P13. sheaves had been maintenance

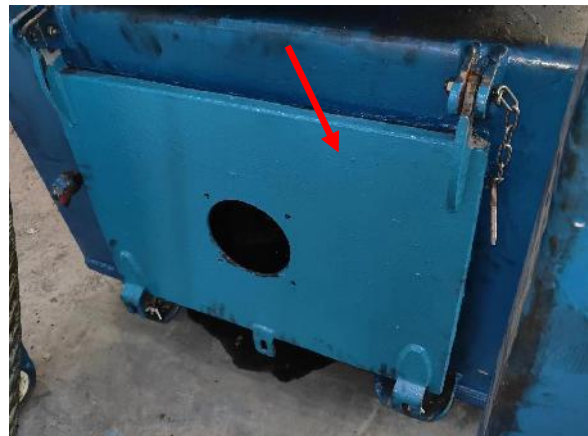
P14. system room door had been renewed

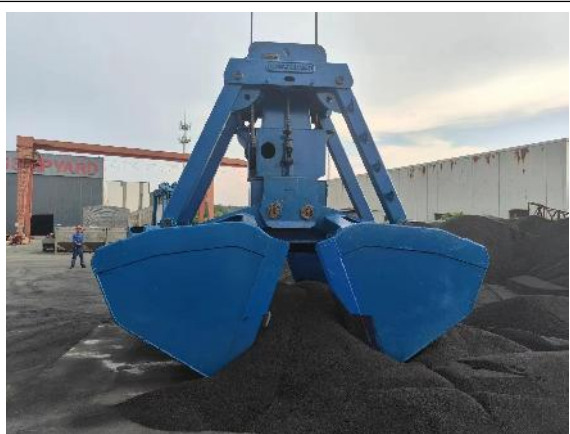
P15.operation testing for grab

- Operation testing had been carried,which was working in normal .Pic.15
- The hydraulic oil tank had been cleaned and the oil had been replaced.all the oil filter had been replaced before filling oil.Pic.16

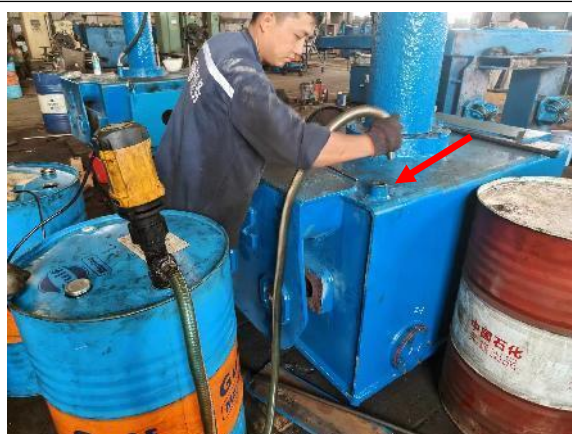
P16. renew the hydraulic oil

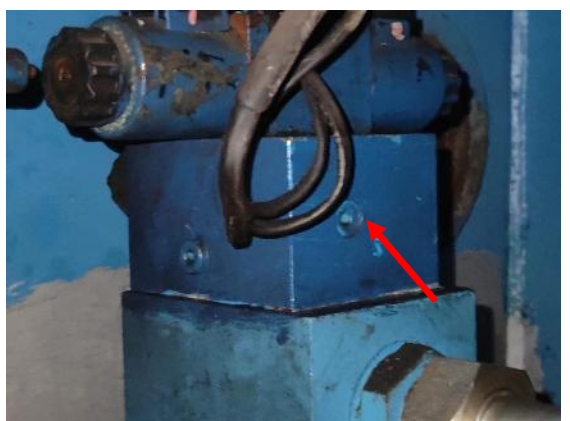
P17. valve block overhauled

- The leaking Valve block and solenoid valves of NO.4 grab had been overhauled and renew the seal kits.Pic.17
- The solenoid valves of NO.3 grab had been replaced.Pic.18

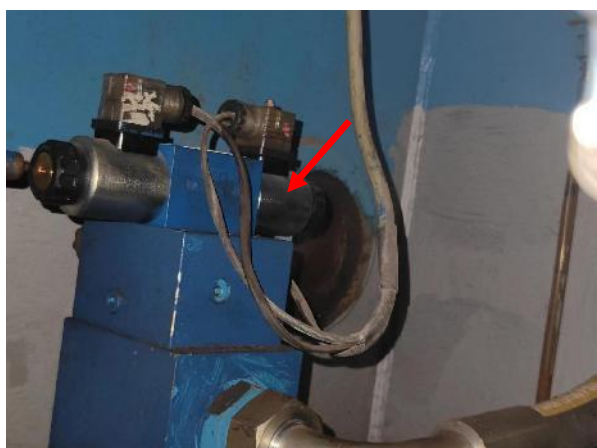
P18. solenoid valves renewed

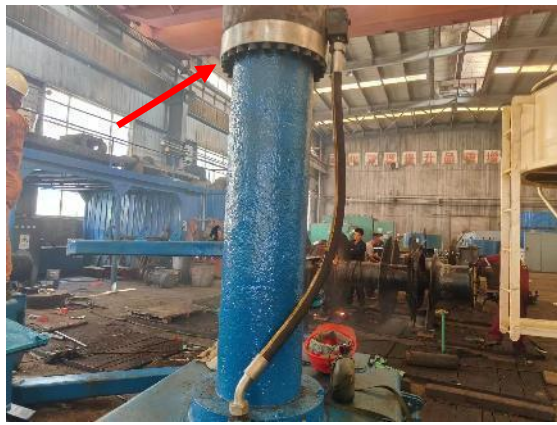
P19. cylinder had been overhauled and top flange renewed

- All the hydraulic cylinder had been overhauled and renew the seal kits .the top flange had been renewed and the cylinder tube had been carried sandblasting and paint.Pic.19

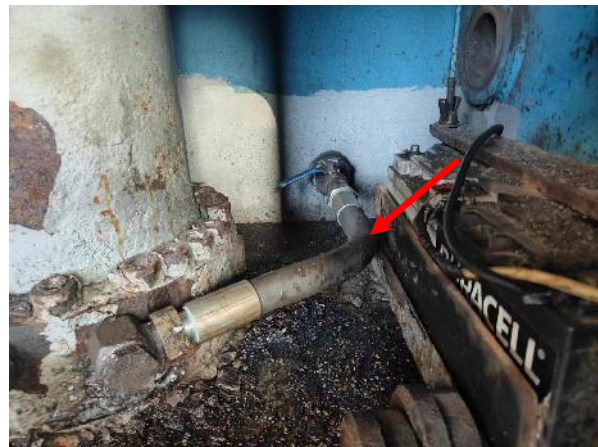
P20. rubber hose had been renewed

- All the rubber hose and adapter had been replaced during this docking repair.Pic.20
- All the air bleeding plug had been replaced.Pic.21
- Air filter for the all 4 grabs had been replaced and the hose of NO.1 air filter had been fitted back.Pic.22

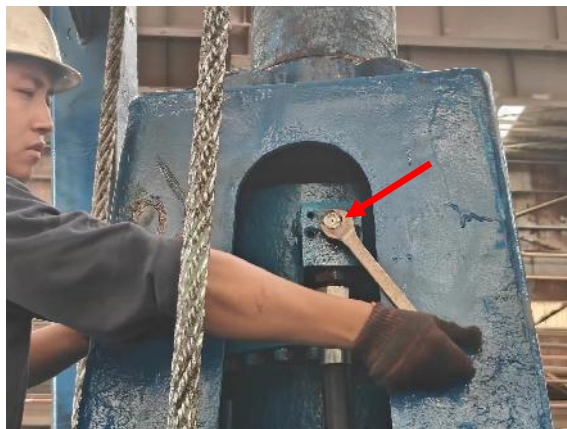
P21. air bleeding plug renewed

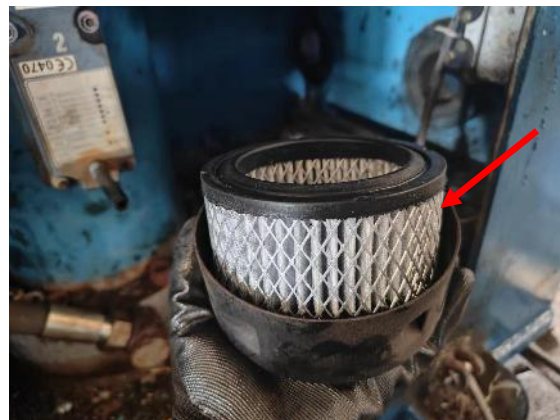
P22. air fitter had been renewed

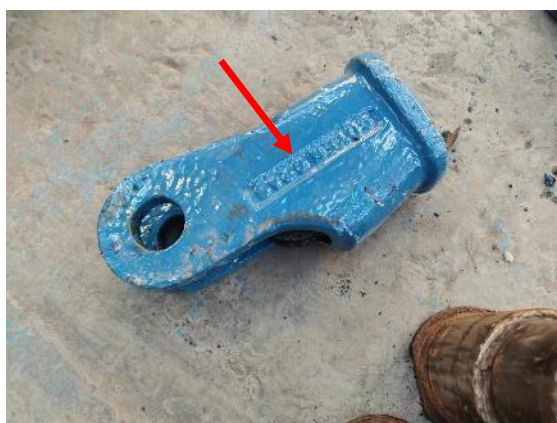
P23. wire socket had been maintenance

- Battery and remote control system are working in normal condition.
- All the wire socket had been dismantled and performed maintenance.Pic.23
- All the emergency manual lever had been performed maintenance and free up.Pic.24

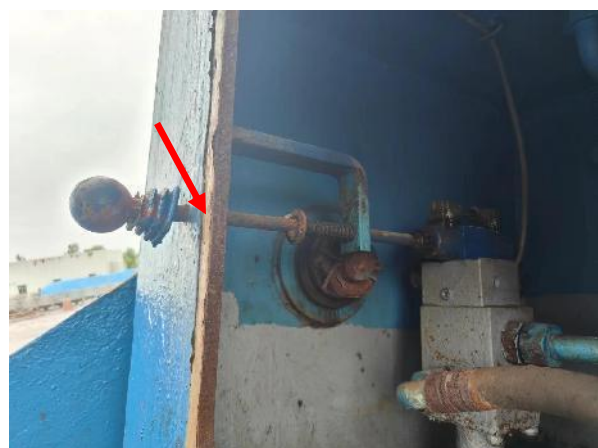
P24. emergency level had been maintenance
