# INSPECTION REPORT

| <b>System Inspected:</b> | FRAMO Cargo and Ballast pumping System |

The present Inspection, at the FRAMO pumping plant onboard the vessel \_\_\_\_\_ was carried out during vessel stay at Chalkis Shipyard, in Greece.

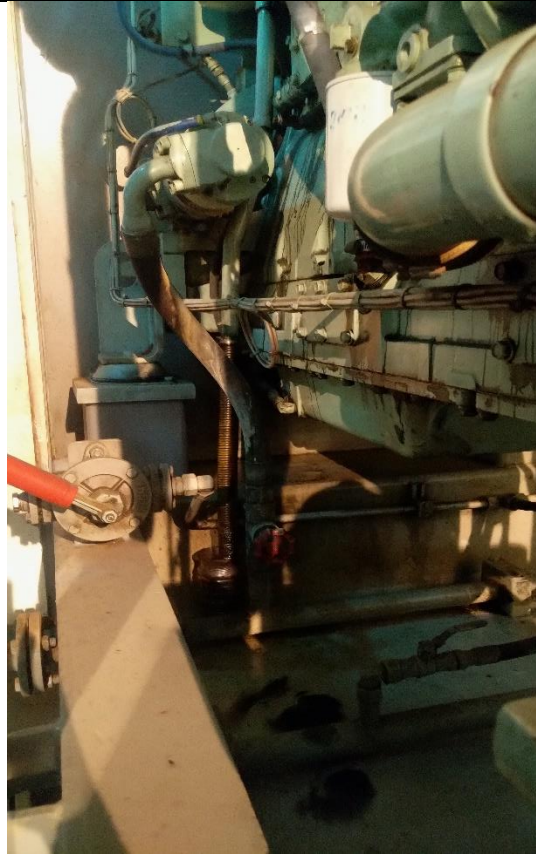
| HPU<br>(Hydraulic power unit) | Normal condition | Acceptable condition | Poor condition |
|---|---|---|---|
| Diesel engine condition | Reported working well, but need revision. | | |
| Engine type: CUMMINS KTA19 | With leakages | | |
| <b>Comments:</b><br>The HPU room and related equipment are in normal condition and cleanliness from HPU area is good. Only subject to take in consideration is the small leakages at suction valves. This must be monitored and if increase, consider replacing the valves seals (can be seal kit for valves instead of expensive complete valve).<br>The diesel engines are showing some leakages. It’s recommended to have some maintenance on it. | | | |

Leakages at Cummins

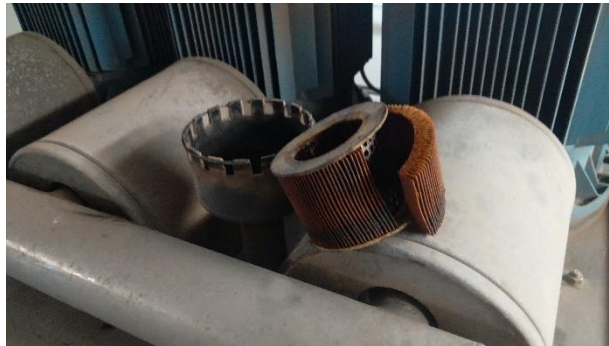
| AUXILIAR UNIT (hydraulic service tank, main filter, and hydraulic oil cooler) | Normal Condition | Acceptable condition | Poor condition |
|---|---|---|---|
| Hydraulic service tank <i>air</i> filter | | | DAMAGED AND CLOGGED |

Air filter from auxiliar unit

- Keep monitoring the **magnetic chip detectors** every operation.
- **Hydraulic oil cooler** has no record of internal cleaning and anodes replacement. When possible clean, test and replace anodes if required.
- **Cummins diesel engines** with leakages. Cause of leakages can be due to gaskets, seals too dry or deformed. During next Cummins engine maintenance, repair the leakages.
- **Air filter** from the auxiliary tank is damaged and very dirty. Replace when possible.

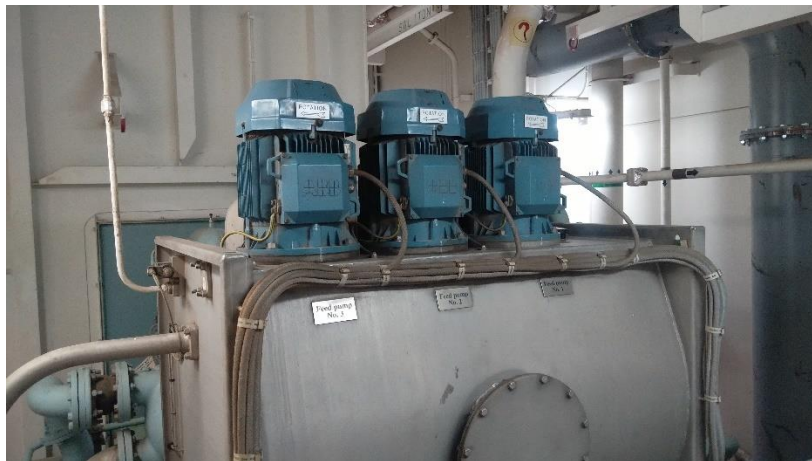
Auxiliary unit

The last hydraulic oil analyses sampling results report we had access indicate that oil is with quantity of particles above recommended. Due to oil contamination is very important to make a new oil sample. Result will indicate what are the actions to be taken in future.

It's of major importance that oil is cleaned as soon as possible. This can be done by replacing all filters and keep system running with minimum 2 PPKS to get enough flow and at having 100bars system pressure. 24hours running should bring most particles, that are loose in the hydraulic system to filter. If this is not done soon, parts like system pressure control valve, relief valves, directional valves, sensors, calibrated orifices, and the pumps from PPKS will not working properly, or will become damage, causing failure and system instability. A kind of particles snowball effect will take place can ending up in complete system breakdown/ stop (one particle will create several and lead to much more, and so on).

After the system is cleaned, **new oil sample must be taken** and analyzed. If value still high system should be flushed a few more times and filters replaced again. It's important to have installed filters with good filtration ratio.

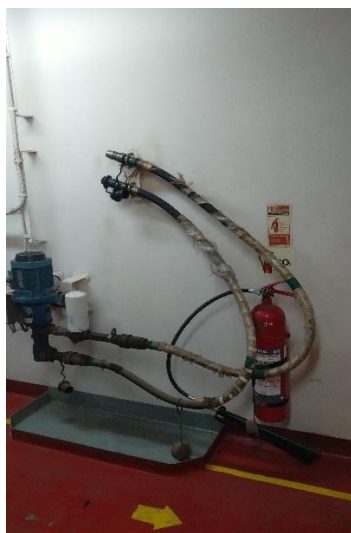
| Comments:<br><i>Normal condition. No actions required for now.</i> | | | |

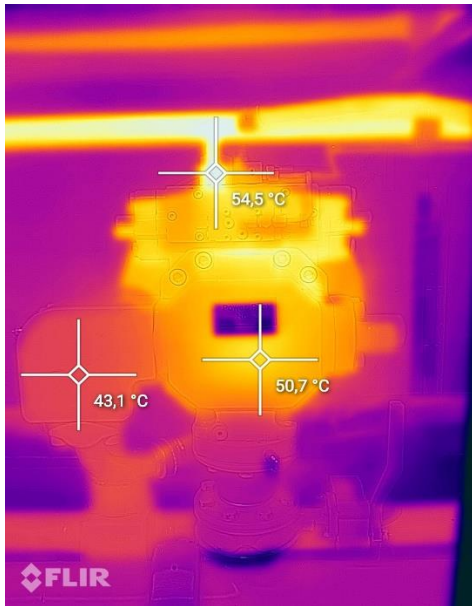
PPK.2

PPks have temperatures within the expected values and difference between inlet, outlet and drain are normal.  
Feed pump has a normal temperature. No actions required.

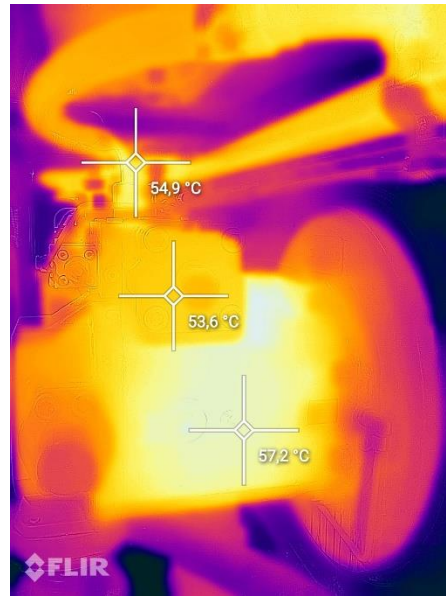
PPK.3

Pressure manifold and cooler temperatures are normal, considering the hydraulic oil temperature and room temperature.

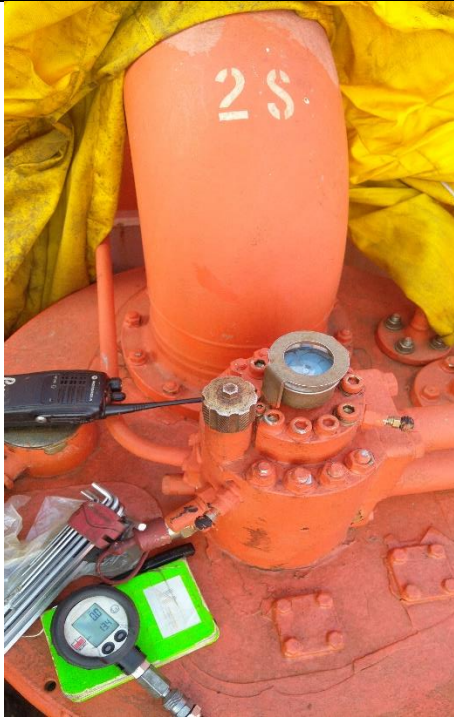
**Top plate arrangement**

The Cargo and SLOP pumps top plates and control valves are in normal conditions. Good preservation work, that should be an ongoing process,

Purging routines did show leakages at pumps cofferdams and our tests done during inspection showed that **cargo pump from tank. 1P, 3P and 4P S have cargo leak**. The one from COP **2P have an oil leak**. Is recommended having the pumps pressure tested and repair according to findings.
